Evaluation of two Vitallium blade-form implants retrieved after 13 to 21 years of function: A clinical report

This article describes the clinical, radiographic, and histologic evaluation of 2 immediately loaded Vitallium blade-form implants retrieved from the posterior maxilla of 2 patients after 21 and 13 years of function. Neither implant demonstrated mobility or signs of pathosis, and both appeared to have integrated well with surrounding bone. The hydroxyapatite coating of the second implant, which was retrieved after 13 years of function, showed no dissolution. These observations suggest that immediately loaded dental implants have the potential to achieve and maintain osseointegration and that hydroxyapatite coatings can resist degradation over long-term service. (*J Prosthet Dent* 2002;87:412-5.)

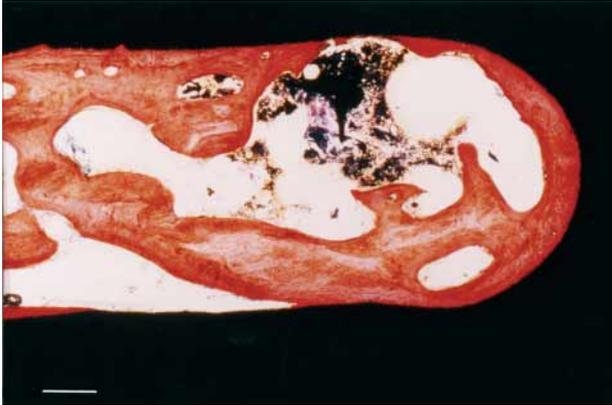
Fig. 2. Implant 21 years after loading: Bone in vent area appears to be in direct contact with implant surface. *White line* represents 400 μm . (Original magnification $\times 4$.)

Both implants appeared to have integrated with surrounding bone (Figs. 2 to 5). In the first patient, the bone appeared to be in direct contact with the implant (Figs. 2 and 3). The vent areas were covered continuously by bone, and fatty tissue was seen within these areas. Mature bone in tight contact with the implant surface was seen across most of the surface. When the implant was observed under polarized light, a remodeling pattern was identified (Fig. 3).

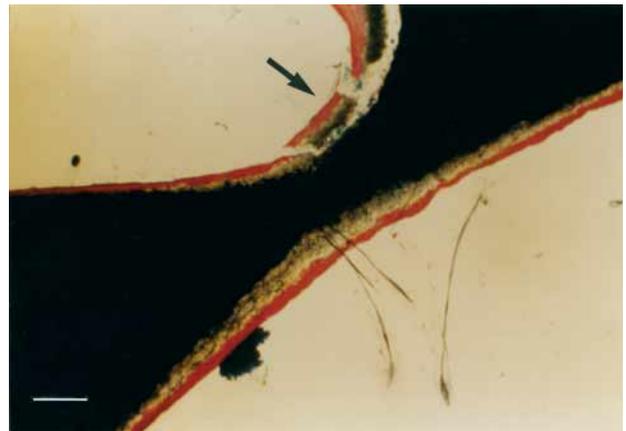
Fig. 4. Implant 13 years after loading: HA coating appears to form continuous layer along implant surface; bone appears in tight contact with coating and with detached HA coating fragments. *White line* represents 400 μm . (Original magnification $\times 4$.)

Similar observations were recorded for the second patient. The bone was in close contact with the coating (Figs. 4 and 5), and the coating appeared as a

continuous layer along the implant surface. A few fragments of the HA appeared to be detached from the implant surface but were still in close contact with the bone (Fig. 4). No evidence of dissolution or degradation of the HA coating was observed. Even under high magnification (Fig. 5), the bone was in contact with the coating, with no intervening space. Thin, fine strands of bone appeared to be inserted into the coating.

Some parts of the coating did appear to be detached from the implant surface (Fig. 4), as previously observed with HA-coated root-form implants.^{31,32} Although frictional stress during implant installation³³ has been shown to cause particle detachment, the particles could have been detached during specimen preparation. They appeared to be in intimate contact with the bone, with no evidence of adverse reaction. Detached coating particles have been correlated with implant failure,³⁴ but a close relationship between bone and detached HA fragments also has been observed under long-term function without any clinical or histologic sign of pathosis.³¹ All currently available data regarding detached coating particles is based in anecdotal reports. An animal study that evaluated the effects of these particles at controlled time periods would provide useful information.
