Histologic evaluation of a threaded hydroxyapatite-coated root-form implant located at a dehiscenced maxillary site and retrieved from a human subject: A clinical report

Periklis Proussaefs, DDS, MS^a

School of Dentistry, Loma Linda University, Loma Linda, Calif.

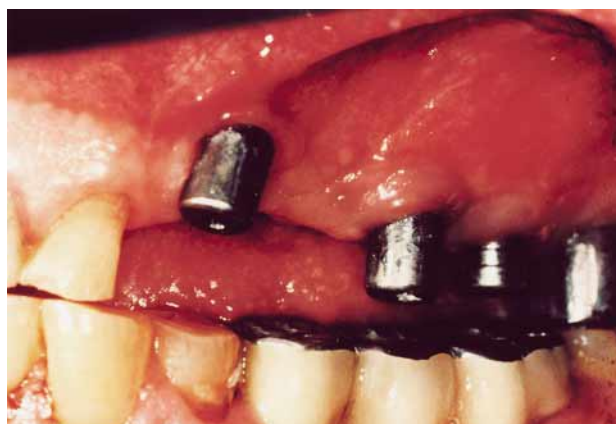
Fig. 1. Implant placed too far buccally in area of maxillary left canine. Note lack of keratinized tissue in buccal area.

University, to receive an implant-supported, screw-retained fixed partial denture for the maxillary left canine to first molar (Fig. 1). Ten months previously, 3 threaded HA-coated root-form implants (Steri-Oss; Nobel Biocare USA, Yorba Linda, Calif.) had been placed by a private practitioner to replace the maxillary left canine, second premolar, and first molar. The implant in the maxillary left canine area appeared to be positioned too far buccally to be restorable. A decision was made to replace that implant with another in a more favorable position. Before implant retrieval, the area around the existing implant was probed at 6 locations: distal-palatal, mid-palatal, mesio-palatal, mesio-buccal, mid-buccal, and distal-buccal. The healing abutment was removed, a cover screw was placed, and a periapical radiograph was taken (Fig. 2).

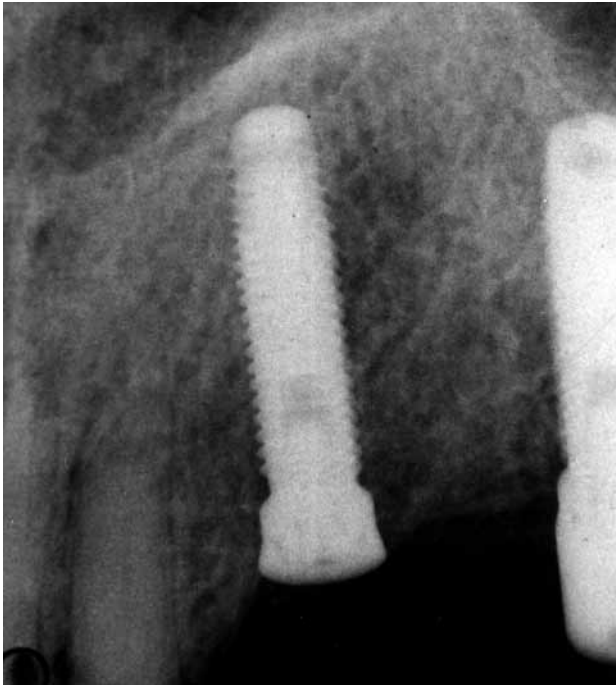
Fig. 2. Periapical radiograph shows no peri-implant radiolucency.

Radiographic findings. A periapical radiograph suggested osseointegration with the surrounding bone, with no sign of peri-implant radiolucency (Fig. 2).

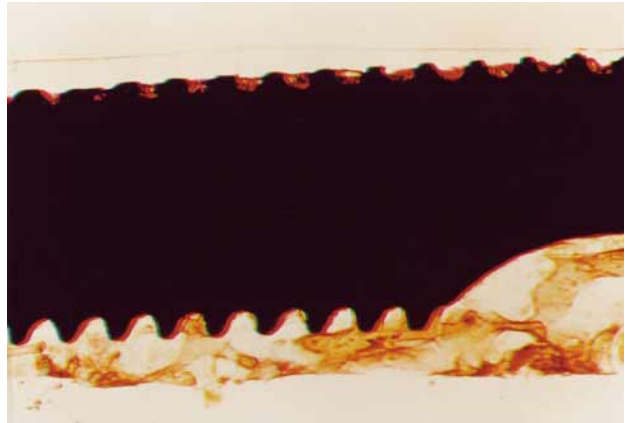
Fig. 4. Histologic overview of retrieved implant (original magnification $\times 2$).

Histologic findings. The implant appeared to be surrounded by mature trabecular bone (Fig. 4), with tight contact between HA and bone. The bone on the palatal aspect of the implant appeared mature and healthy with osteocytes present. Excellent trabecular bone remodeling could be observed close to the implant (Figs. 5 and 6). The HA coating was present with no signs of active resorption. The tips of the implant threads were denuded of the HA coating, and the exposed metal surface was in close contact with bone (Fig. 5). On the buccal side of the implant, which was in contact with soft tissue, large and sometimes multinucleated cells were observed (Fig. 7). These cells were consistent with macrophages and

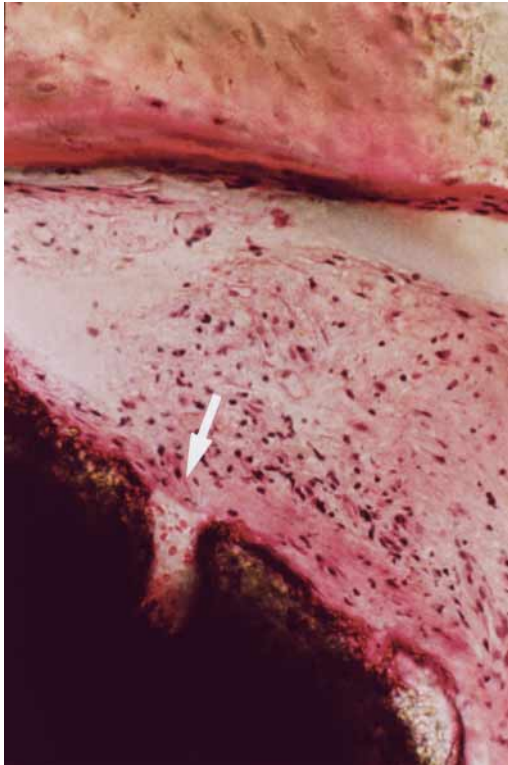
Fig. 8. Indentations along implant surface (*arrow*) and mild inflammatory cell infiltrate suggest focal loss of HA (original magnification $\times 20$).

osteoclasts. A mild-to-moderate inflammatory cell infiltrate was observed, as were indentations and focal regions of HA loss (Fig. 8).

a nonbony surface may be prone to dissolution.^{7,17,20-22} The indentations along the coating surface (Fig. 8), the presence of macrophages, and the inflammatory process on the dehisced surface of the implant (Fig. 7) could be perceived as an active resorptive process of the HA. It appears that the use of titanium noncoated implants in areas with a bony dehiscence^{30,31} may be advantageous. Further research is needed to validate this hypothesis.
