Histologic Evaluation of Threaded HA-Coated Root-Form Implants After 3.5 to 11 Years of Function: A Report of Three Cases

This article presents a histologic evaluation of three hydroxyapatite (HA)-coated root-form implants retrieved from humans after being in function for 3.5 to 11 years. If the coronal portion, where bone loss was observed clinically and radiographically, is excluded, all implants appeared to be well osseointegrated, with intimate contact between the surrounding bone and the coating. There was no sign of resorption or dissolution of the HA coating. The coating had a uniform thickness (50 μm) equal to the thickness originally provided by the manufacturer. In the few areas where there was no bone contact, the HA coating appeared to line the implant with no sign of dissolution. The few detached particles had tight contact with the bone, demonstrating the biocompatibility of the HA. The observations from the three reported cases suggest that the HA coating of dental implants may not be susceptible to resorption or dissolution under long-term function. (Int J Periodontics Restorative Dent 2001;21:21-29.)

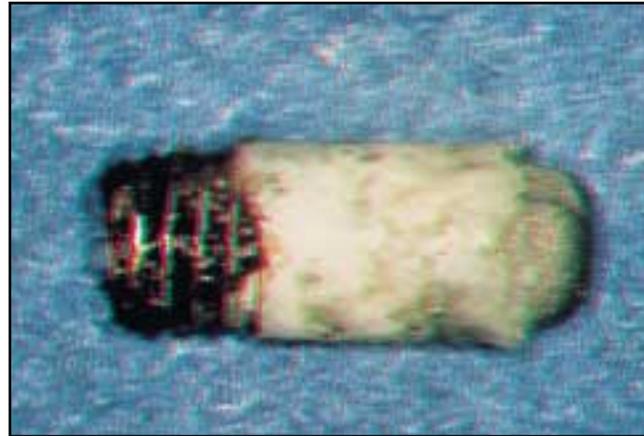
Fig 2 Case 1 immediately after retrieval of the implant. The bone is tightly attached to the implant surface.

A 54-year-old woman presented with pain in the right posterior maxillary area that was intensified upon function. Radiographic examination revealed a fractured implant in the area of the maxillary right second molar. The implant was a 3.8 mm × 12 mm threaded, HA-coated root-form implant (Steri-Oss, Nobel Biocare) that had been placed at LLU in October 1988. The implant was removed in July 1999 (Fig 2).

percussion was elicited from the fractured implant in case 1. The implants studied in this article exhibited no mobility. In all cases, the surrounding bone was well attached to the implant surface during retrieval (Fig 2). The attached bone appeared to cover the apical 75%, 50%, and 60% of the retrieved implants in cases 1, 2, and 3, respectively.

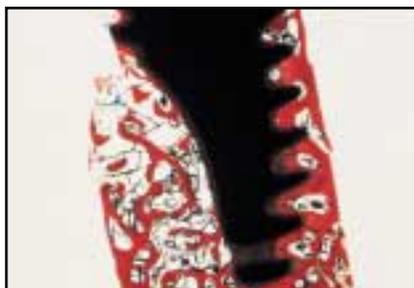
Fig 3b Histologic overview of the implant in case 2. (Original magnification $\times 2.5$; Stevenel's blue–Van Gieson's picric fuchsin stain.)

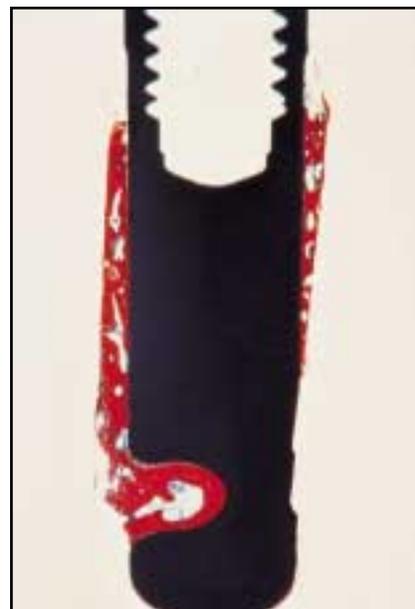
Fig 3c (right) Histologic overview of the implant in case 3. (Original magnification $\times 2$; Stevenel's blue–Van Gieson's picric fuchsin stain.)

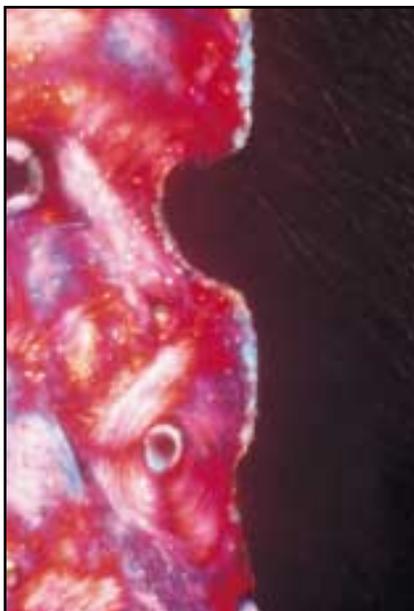
The bone around the implants appeared to be in a remodeling phase, as polarized microscopy revealed (Figs 4a and 4b). In addition, Haversian canals could be frequently observed at a 50- to 80-µm distance from the bone-implant interface, emphasizing the remodeling pattern (Fig 4c).

Fig 4a Case 1. Coating forms a uniform layer along the surface of the implant and appears to be in intimate contact with the surrounding bone. At the tips of the threads, there appears to be a lack of coating, and the exposed titanium surface appears integrated with the surrounding bone. (Original magnification $\times 10$; Stevenel's blue–Van Gieson's picric fuchsin stain.)

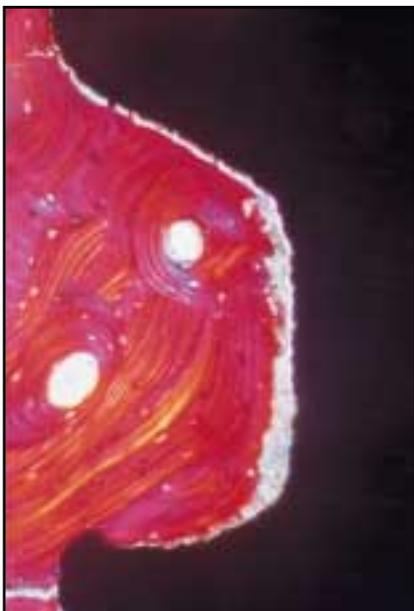
Fig 4b Polarized microscopy emphasizes the remodeling pattern of the bone around the implant in case 1. (Original magnification $\times 20$; Stevenel's blue–Van Gieson's picric fuchsin stain.)

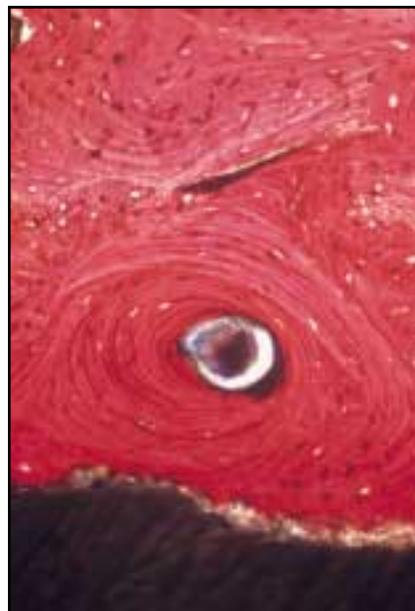
Fig 4c Haversian canals are identified in close proximity to the implant-bone interface. (Original magnification $\times 20$; Stevenel's blue–Van Gieson's picric fuchsin stain.)

The presence of Haversian canals in close contact with an HA-coated implant surface (Fig 4c) has been demonstrated in both animal^{6,10} and human^{29,32} studies. This emphasizes the periimplant remodeling activity.⁵² On the other hand, titanium^{53,54} and titanium plasma-sprayed implants⁵⁵ retrieved from humans after long-term function have shown similar results to the current specimens. It is unknown if the tight contact between the implant surface and the bone in the present specimens can be attributed to the properties of the HA or if it is a result of a continuous bone remodeling.

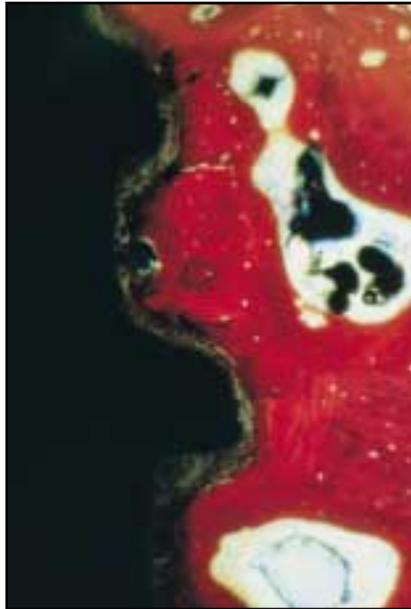
the threads of the implant (Fig 5). When seen under high magnification, the coating demonstrated intimate contact with the bone (Fig 6). The bone had a saw-like appearance along the implant surface. Thin, fine strands of bone seemed to insert into the irregularities of the coating.

Fig 5a (left) Case 2. Note the continuous layer of the coating that appears to have uniform thickness and be almost 100% integrated with the surrounding bone. (Original magnification $\times 10$; Stevenel's blue–Van Gieson's picric fuchsin stain.)

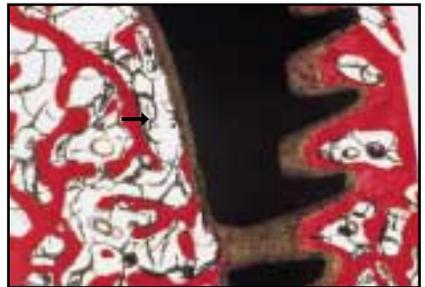
An interesting observation was made at one side of the implant from case 2, where there was no bone along the coating surface (Fig 7). Despite the lack of bone contact, the HA appeared to have a continuous lining along the implant surface.

Fig 7 (right) Case 2. Part of implant surface appears to not be in contact with bone (arrow). Coating appears to have a continuous layer with a uniform thickness, even in areas with no bone contact. (Original magnification $\times 4$; Stevenel's blue–Van Gieson's picric fuchsin stain.)

It has been reported that HA coatings may be susceptible to dissolution when they are not in contact with bone.^{45,46} In the specimen from case 2, the coating lacked contact with bone in some areas. However, no dissolution of the HA had occurred. It may be hypothesized that the lack of bony contact could represent only a predisposing factor for coating dissolution and other factors are involved in the dissolution of the HA coating.

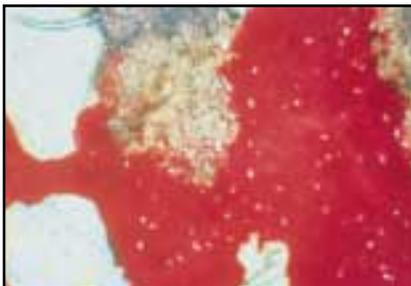
In the areas where small particles of the coating had been detached from the implant, a tight contact between the surrounding bone and the majority of the surface of the particles was observed (Fig 8). A similar saw-like interface between the bone and the coating was noticed.

Fig 8 (left) Case 2. Some HA particles appear detached from the implant surface. They appear to have tight contact with the surrounding bone along the majority of the surface. (Original magnification $\times 20$; Stevenel's blue–Van Gieson's picric fuchsin stain.)

mechanism (biointegration) may exist between the HA-coated implant surface and the surrounding bone.^{42,43} The few HA particles that lacked tight contact with the metal surface (Fig 8), probably because of mechanical dislodgment during implant placement,⁴⁴ appeared integrated with the bone, as has been previously observed.³⁶ This observation emphasizes the biocompatibility of the coating.

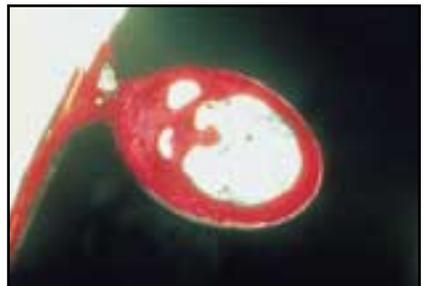
The apical vent of the implant in case 3 was covered continuously by bone (Fig 9). A uniform layer of the coating was observed, and the bone appeared in direct contact with the implant surface in almost 100% of the internal surface of the vent. Fatty tissue was seen in the vent area.

Fig 9 (right) Case 3. Area inside vent of the implant is almost 100% integrated with bone. Note coating layer along the internal surface of the vent and intimate bone–HA interface. (Original magnification $\times 4$; Stevenel's blue–Van Gieson's picric fuchsin stain.)
