Histologic Evaluation of a 9-year-old Hydroxyapatite-coated Cylindric Implant Placed in Conjunction with a Subantral Augmentation Procedure: A Case Report

Periklis Proussaefs, DDS, MS¹/Jaime Lozada, DDS²

The histologic examination of dental implants retrieved from humans provides a unique opportunity to evaluate the bone-implant interface. This case report presents a clinical, radiographic, and histologic evaluation of a cylindrical hydroxyapatite- (HA) coated implant retrieved from the posterior maxillary area of a patient after 9 years after placement. The implant had been placed in conjunction with a subantral augmentation procedure with HA as the graft material. Clinical examination revealed an immobile implant with no sign of pathosis. Radiographic examination indicated close proximity of the bone to the implant surface without evidence of radiolucency. Histologically, because of tissue destruction during implant retrieval, only the apical portion of the implant was available for examination under light microscopy, and it appeared to be integrated with the surrounding bone; 45.9% of the surface of the implant had close bone apposition at the interface. There was no evidence

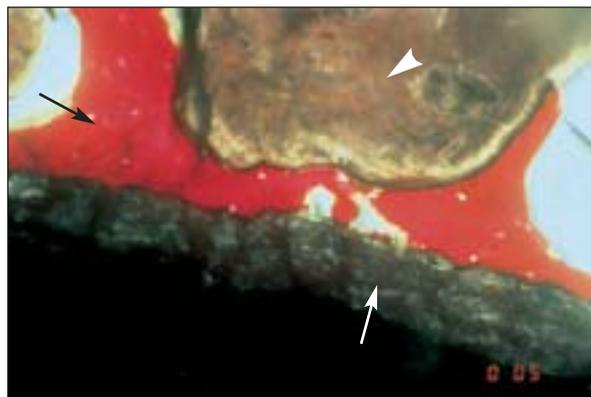
Fig 3b Bone (*black arrow*) was in direct contact with the HA coating (*white arrow*) and with residual graft material (*white arrowhead*) (original magnification $\times 20$).

The apical portion of the implant was preserved during retrieval and evaluated under light microscopy (Fig 2). The implant surface appeared to be in contact with either bone or connective tissue (Fig 3a). The HA coating had a uniform thickness regardless of its contact with bone or connective tissue (Fig 3b). The residual graft particles appeared to be in close contact with the implant surface; however, there was always bone (Figs 3b and 3c) or connective tissue (Fig 3d) between the graft particles and the implant surface. No contact between the residual graft material and the implant surface was observed. The vent area of the implant appeared to have almost 100% BIC (Fig 4), with bone lining nearly the entire internal vent surface. No sign of inflammation or resorption of either the coating or the residual HA graft material was seen.

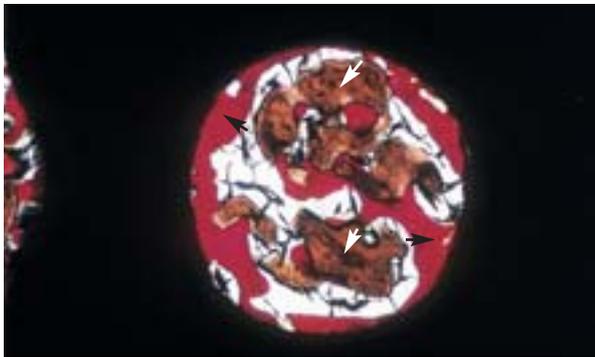
Fig 4 The internal vent area appeared to have almost 100% bone-to-implant contact. Bone (*black arrows*) lined the vent surface, with residual HA material (*white arrows*) in the middle being in tight contact with the surrounding bone. Bony islands connected the graft particles (original magnification $\times 20$).
